RFP 2015C-07
Design/Build: Fire Academy Burn Bldg. W-4
Renovation

Structural Assessment Live Fire Training
Building

Prepared by: Structural Engineers Group, Inc.

November 21, 2011

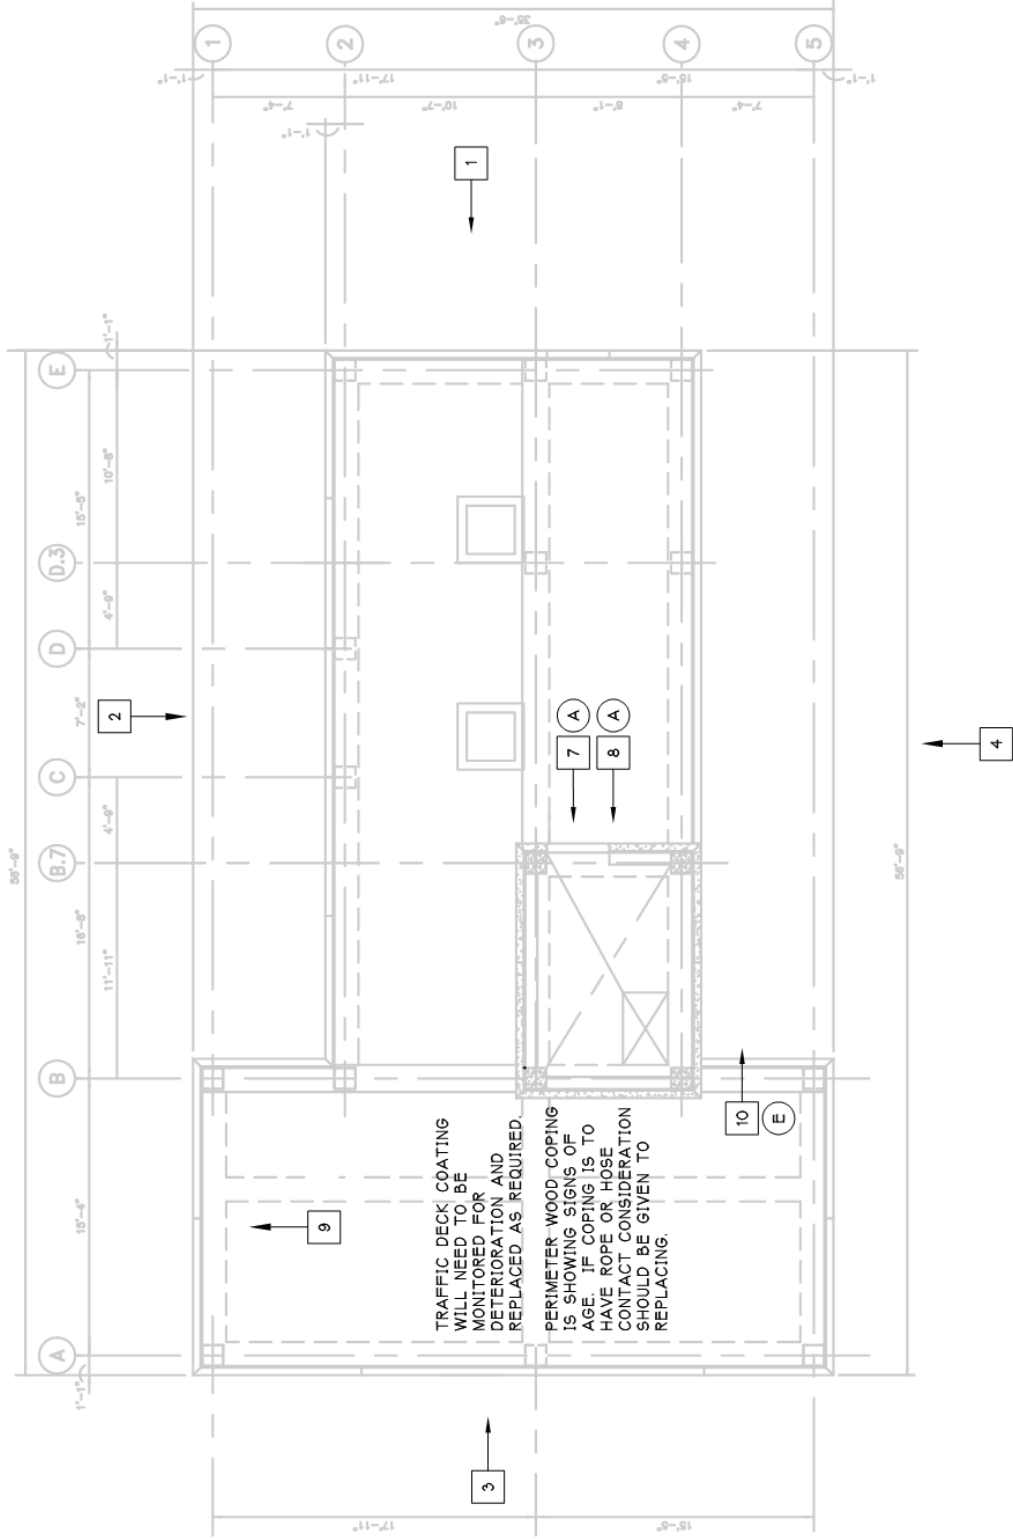
PENTHOUSE FLOOR/ROOF PLAN
 NOT TO SCALE

TRAFFIC DECK COATING
 WILL NEED TO BE
 MONITORED FOR
 DETEIORATION AND
 REPLACED AS REQUIRED.
 PERIMETER WOOD COPING
 IS SHOWING SIGNS OF
 AGE. IF COPING IS TO
 HAVE ROPE OR HOSE
 CONTACT CONSIDERATION
 SHOULD BE GIVEN TO
 REPLACING.

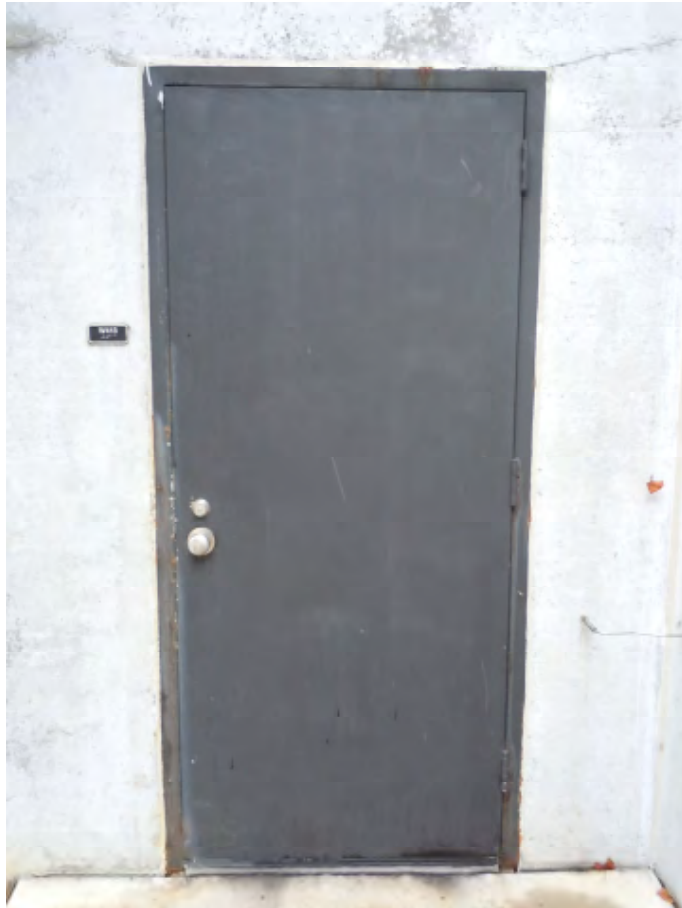
Photo #5 Exterior Door, East Elevation

| <i>Photo #</i> | <i>Location and Description</i> |
|---|---|
| <i>5</i> | Ground level, east elevation, rusted door frame |

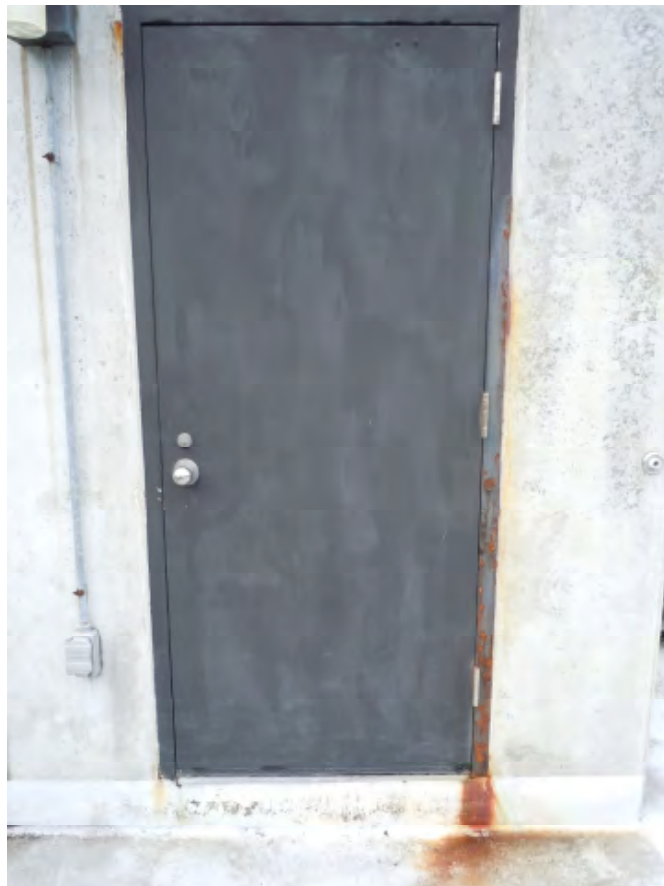
Photo #8 - High Roof, South Side

| <i>Photo #</i> | <i>Location and Description</i> |
|---|---|
| <i>8</i> | High roof level, south side, rusted door frame |

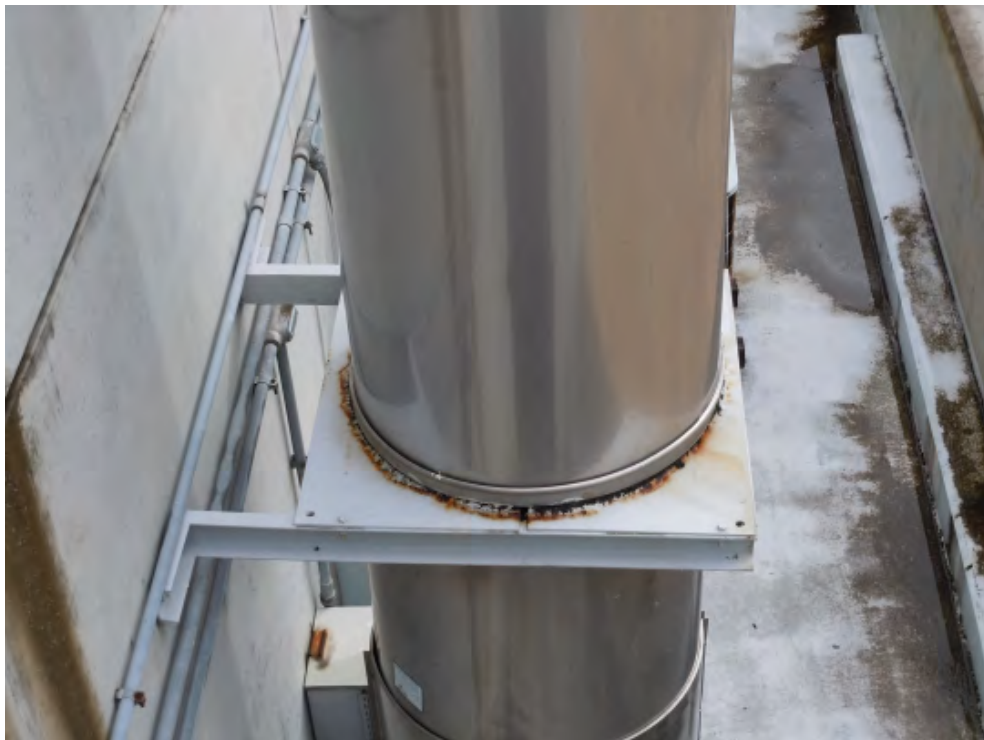
Photo #10 - Low Roof, South Side

| <i>Photo #</i> | <i>Location and Description</i> |
|---|---|
| <i>10</i> | Low roof level, rusted bracket |

- D ALL DOOR HINGES NOT REPLACED NEED TO BE CLEANED AND LUBRICATED.
- E CLEAN PRIME AND PAINT ALL CORRODED PIPE AND STACK BRACKETS AS DESCRIBED IN A AND B ABOVE.

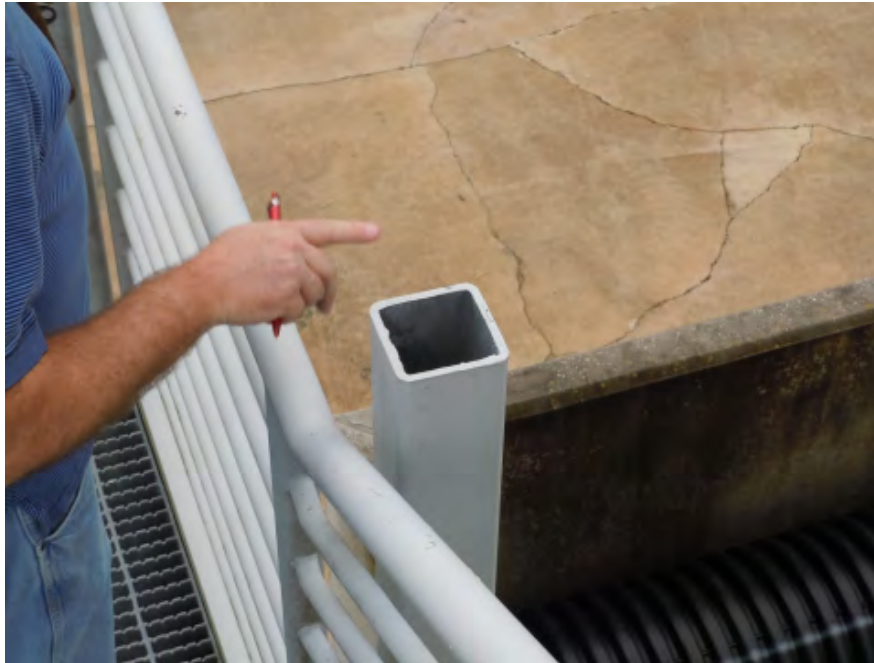
Photo #11 - Exterior Stair

| <i>Photo #</i> | <i>Location and Description</i> |
|---|---|
| <i>11</i> | Exterior Stair, lack of column cap |

- I REMOVE AND MAINTAIN REMOVAL OF ALL VEGETATION ON ROOF.
- J. REPLACE BROKEN LIGHT BULB AND INSTALL PROTECTIVE GLOBE.
- K. PROVIDE STEEL CAP PLATE ON STAIR COLUMNS. DRILL DRAINAGE / VENT HOLE AT BASE OF COLUMNS. STANDING WATER IN COLUMNS.

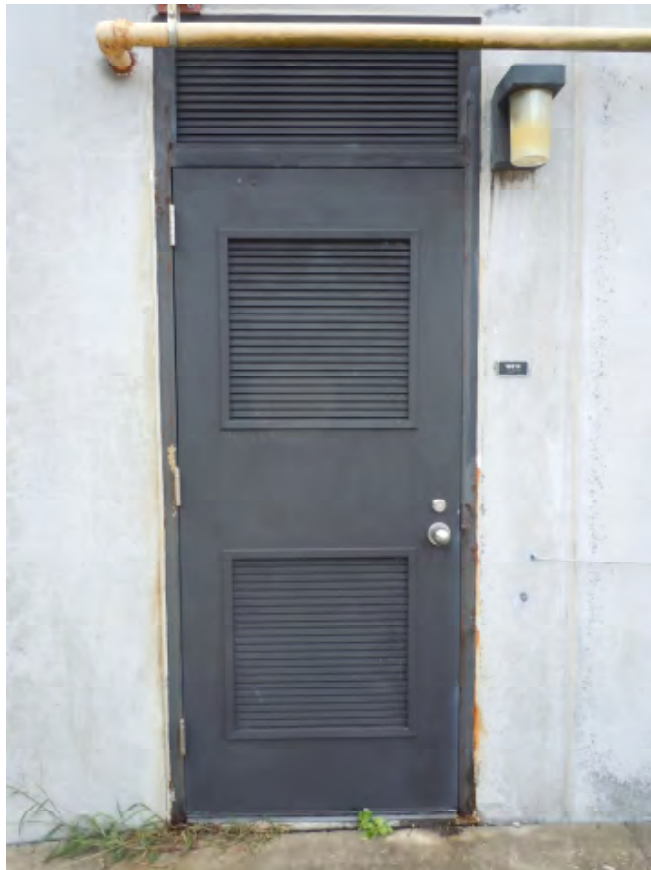
Photo #12 - North Elevation, East End

| <i>Photo #</i> | <i>Location and Description</i> |
|---|---|
| <i>12</i> | North elevation, east end, rusted door frame |

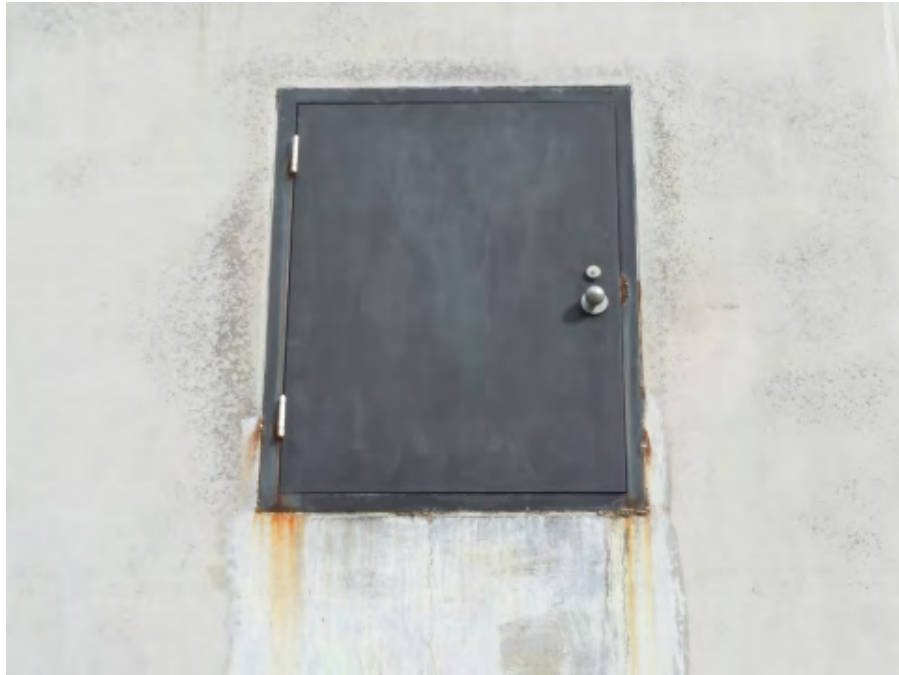
Photo #13 - South Elevation, West End

| <i>Photo #</i> | <i>Location and Description</i> |
|---|---|
| <i>13</i> | South elevation, west end, rusted door frame and sticking door |

- F REPLACE DOOR SWEEP.
- G RE-ATTACH ALL LOOSE STAINLESS EXPANSION JOINT COVERS AT INTERIOR MASONRY PARTITIONS.
- H STICKING OR NON-WORKING DOOR OR LOCKSET. REPLACE PARTS OR RE-WORK AS REQUIRED TO ALLOW FOR PROPER FUNCTION.

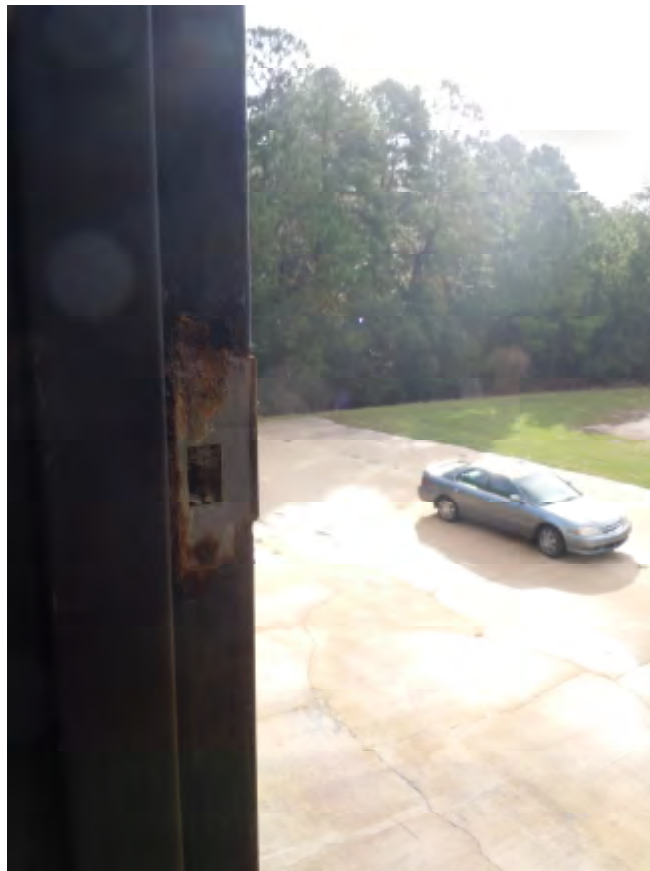
Photo #14, South Elevation , West End

| <i>Photo #</i> | <i>Location and Description</i> |
|---|---|
| <i>14</i> | South elevation, west end, rusted strike plate for door in photo 13 |

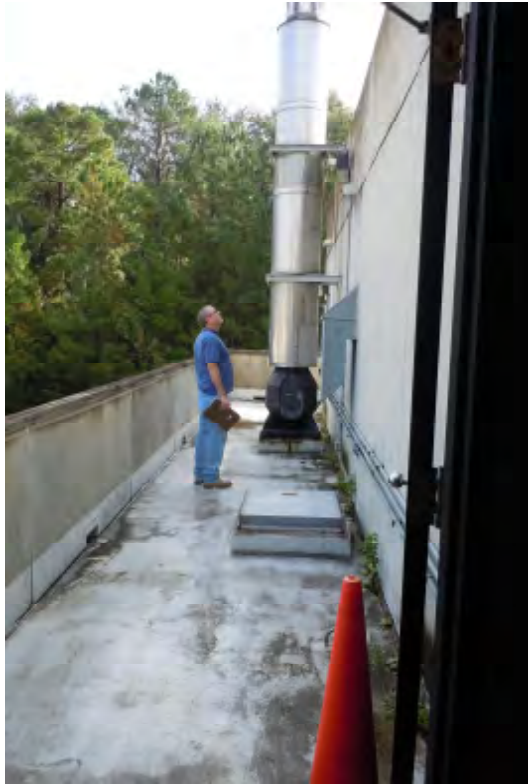
Photo #15 - Low Roof, North Side, Looking East

| <i>Photo #</i> | <i>Location and Description</i> |
|---|---|
| <i>15</i> | Low roof, north side, looking east, plant growth |

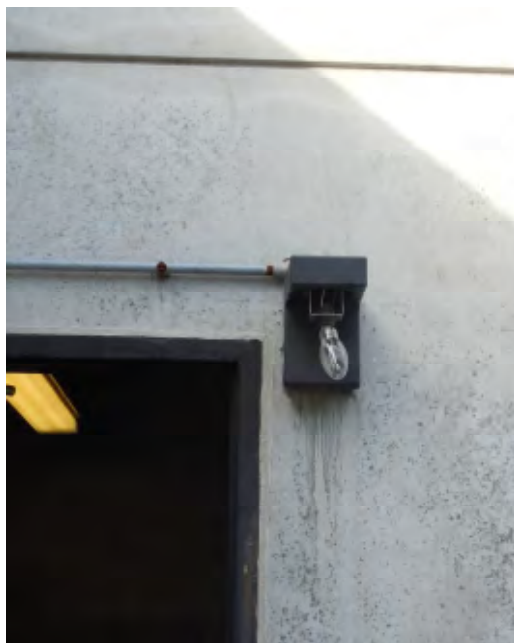
Photo #16 - Low Roof, North Side, Looking West

| <i>Photo #</i> | <i>Location and Description</i> |
|---|---|
| <i>16</i> | Low roof, north side, looking west, broken light and missing globe |

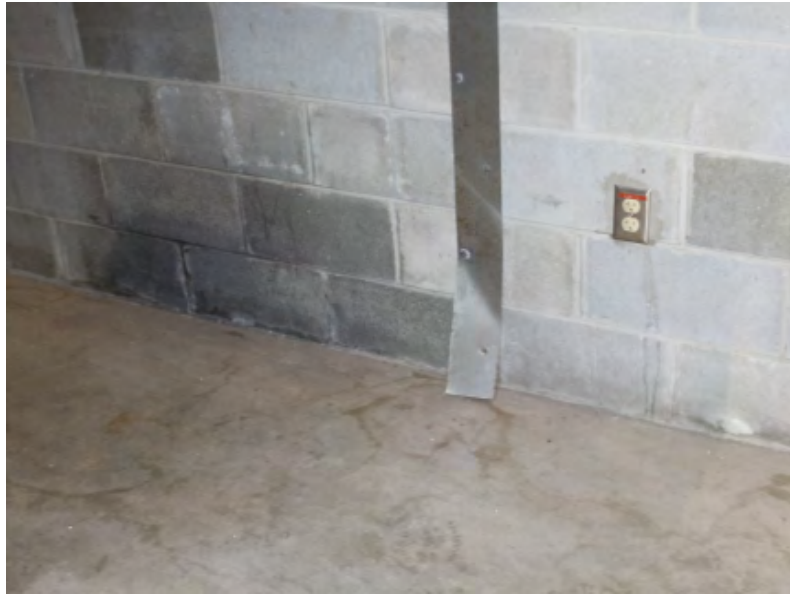
Photo #17, Second Floor Corridor, North End

| <i>Photo #</i> | <i>Location and Description</i> |
|---|---|
| <i>17</i> | Second Floor, Interior corridor, loose joint cover |

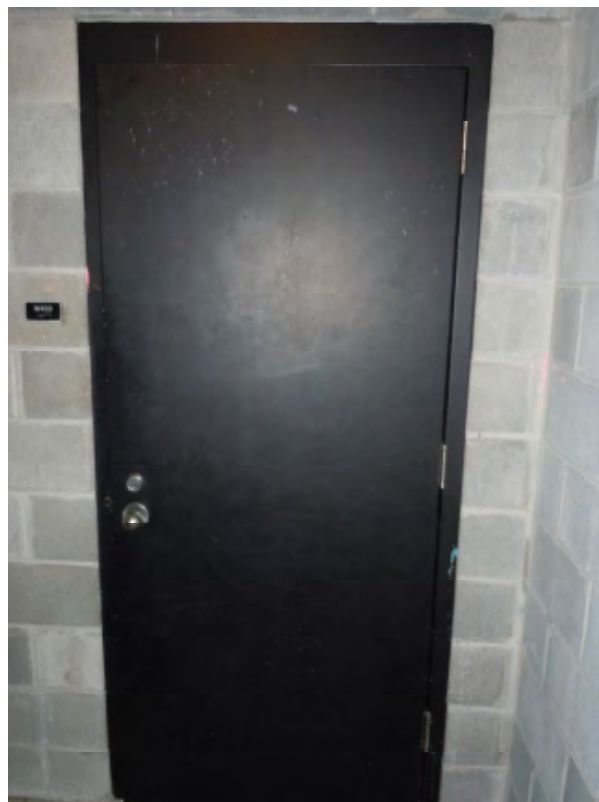
Photo #18, Second Floor, Vestibule to Maze

| <i>Photo #</i> | <i>Location and Description</i> |
|---|---|
| <i>18</i> | Second Floor, Vestibule to maze, sticking door |

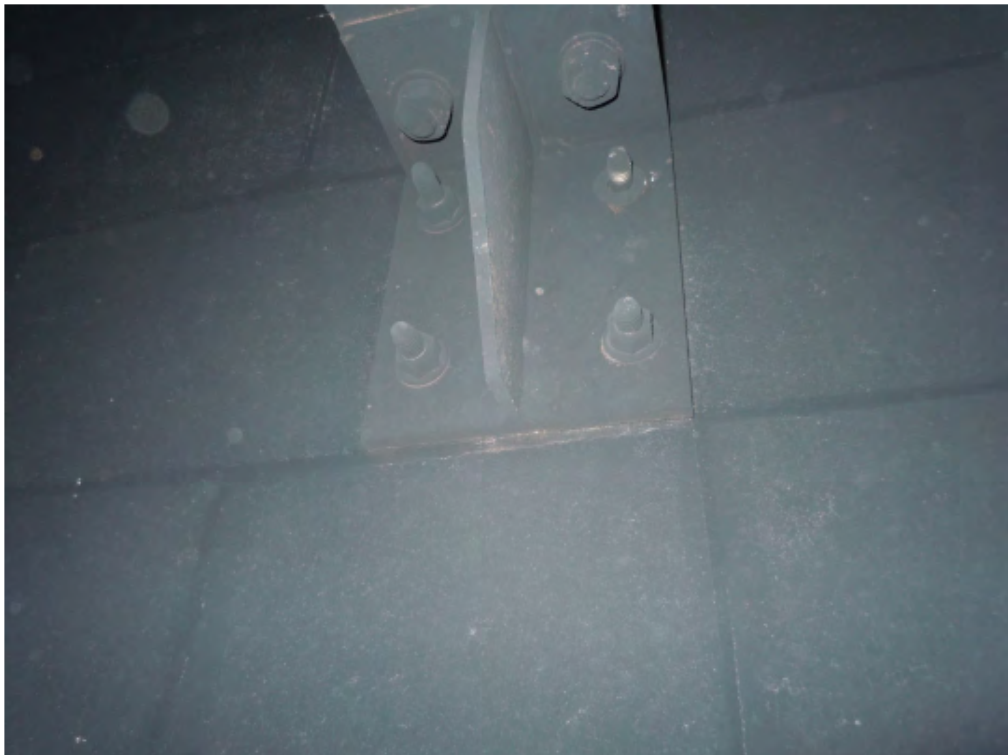
Photo #28 - Scenario Room #4 (SW) Missing Nut

| <i>28</i> | Scenario Room #4 (SW) Missing Nut |
