November 21, 2014

ECS Project No. 24-5190

SUBJECT: Pre-Renovation Asbestos Survey
Red Brick Building
522 North Howard Avenue
Tampa, Florida 33606

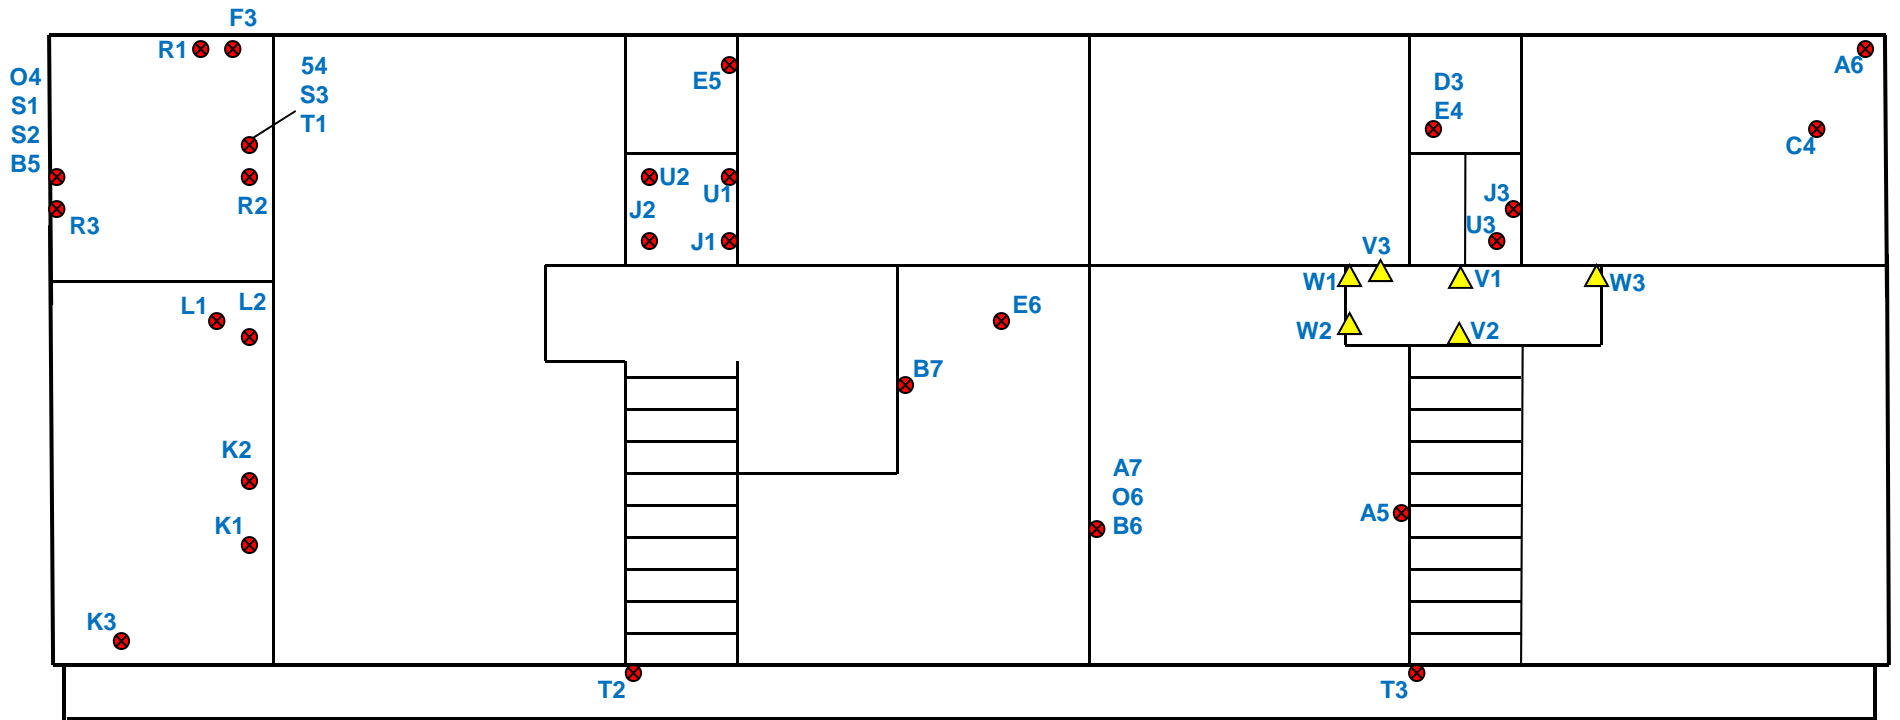
MRI Architecture Group, Inc.
ECS Project No. 24-5190
November 2014
Figure 1

- **The laboratory reported the 9" brown vinyl floor tile located in Vault 2 (southern vault) to contain 2% chrysotile asbestos and the mastic associated with the tiles to contain 5% chrysotile asbestos.**
- **The laboratory reported the 9" cream vinyl floor tile located in Vault 2 (southern vault) to contain 2% chrysotile asbestos and the mastic associated with the tiles to contain 5% chrysotile asbestos.**

Sample Location Diagram First Floor (Interior)

ECS recommends that these materials be properly removed by a Licensed Florida Contractor.

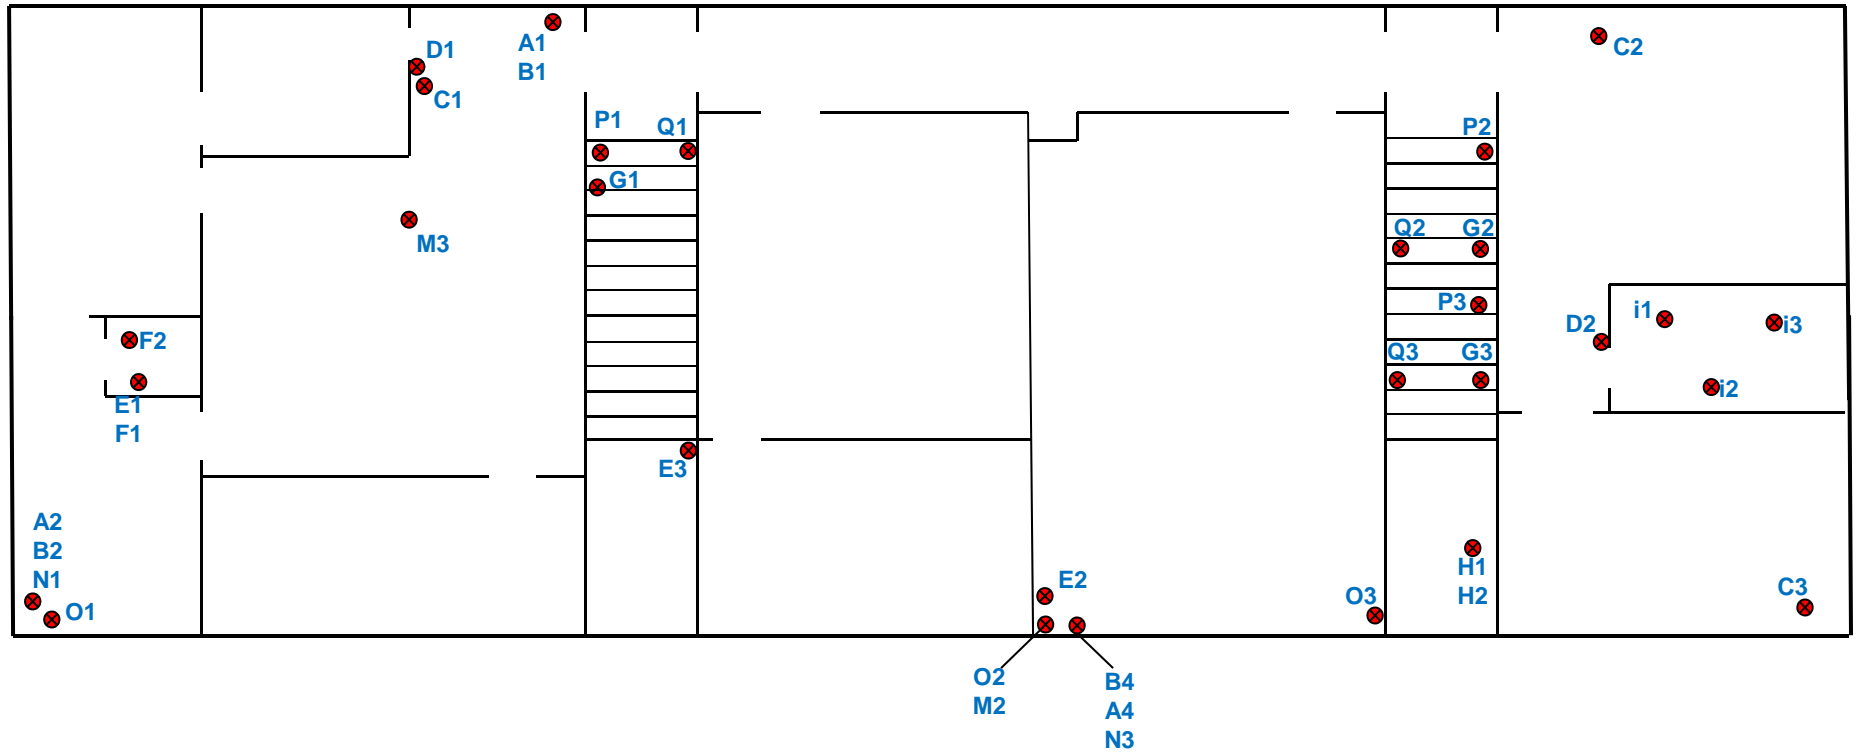
MRI Architecture Group, Inc.
ECS Project No. 24-5190
November 2014
Figure 2

Sample Location Diagram Second Floor (Interior)
