ADDENDUM No. 3

**Addendum To: DEP Solicitation No. 2016002C, entitled
"Seagrass Damage Assessment and Restoration Planning and Implementation in NW Florida"**

PROJECT AUTHORS: Chris Gudeman, Ron Mezich, Kent Smith and Paul Carlson

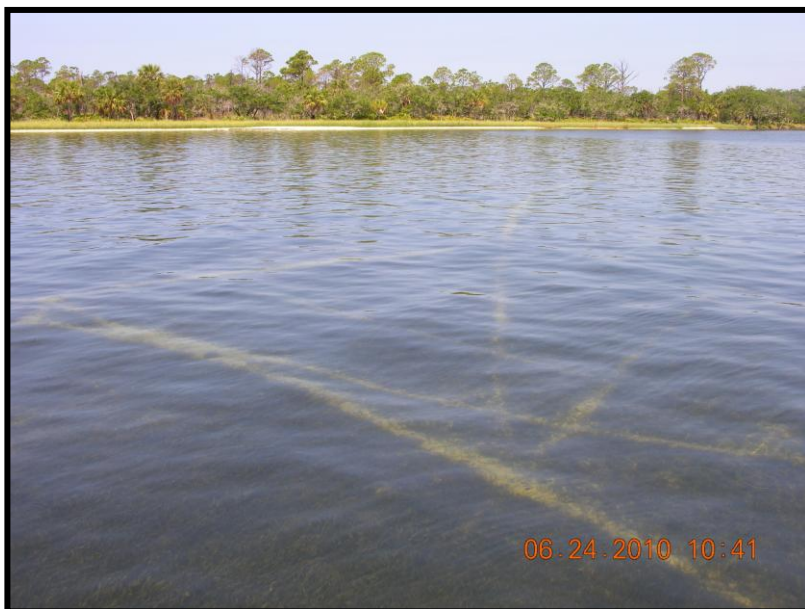
Figure 1. Numerous propeller scars are adversely affecting the seagrass beds on the bayside of Shell Island in St. Andrews Bay Aquatic Preserve.

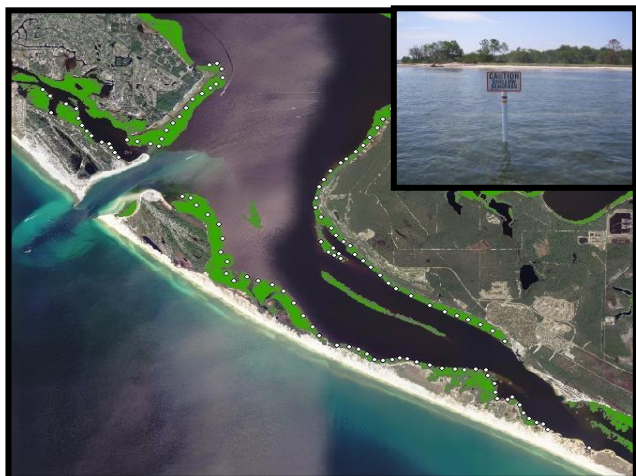
Figure 4. St. Andrews Bay “Caution Seagrass” sign locations are indicated in white.

to, or in seagrass beds threatened with potential prop scarring (Fig. 4). This established a non-regulatory seagrass protection zone that alerted boaters to the locations of shallow seagrass beds at eye-level on the water. This effort was supplemented with informational Kiosks and pamphlets that were provided at local boat ramps providing vessel operators information emphasizing the ecological benefits of seagrass and how to avoid prop scarring (Fig. 5). Data based on observations of vessels and their operator including boat speed, vessel groundings, sediment displacement from propellers, operators tilting motors and vessel operators avoiding areas signed with “Caution Shallow Seagrass” signs were collected to determine the relative effects before and after management strategies were employed by park staff. These data were collected and analyzed based on vessel operator behavior within the aquatic preserve areas marked with “Caution Shallow Seagrass” signs. A detailed account of

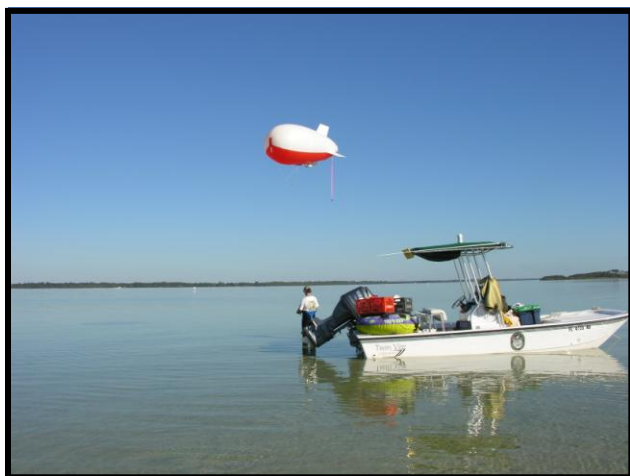
Figure 9. FWRI staff with helium balloon used for propeller scar aerial photography in St. Andrews Bay Aquatic Preserve.

Aerial surveys were conducted using a tethered helium balloon that carried a digital camera, with a 35mm focal length lens, to an altitude between 100 m and 125 m. Each photograph

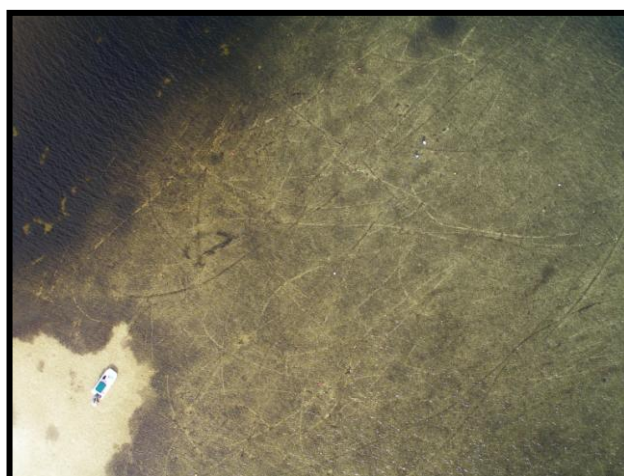
Figure 10. Balloon aerial photography of existing propeller scars at project site A (Cove) in St. Andrews Bay Aquatic Preserve.

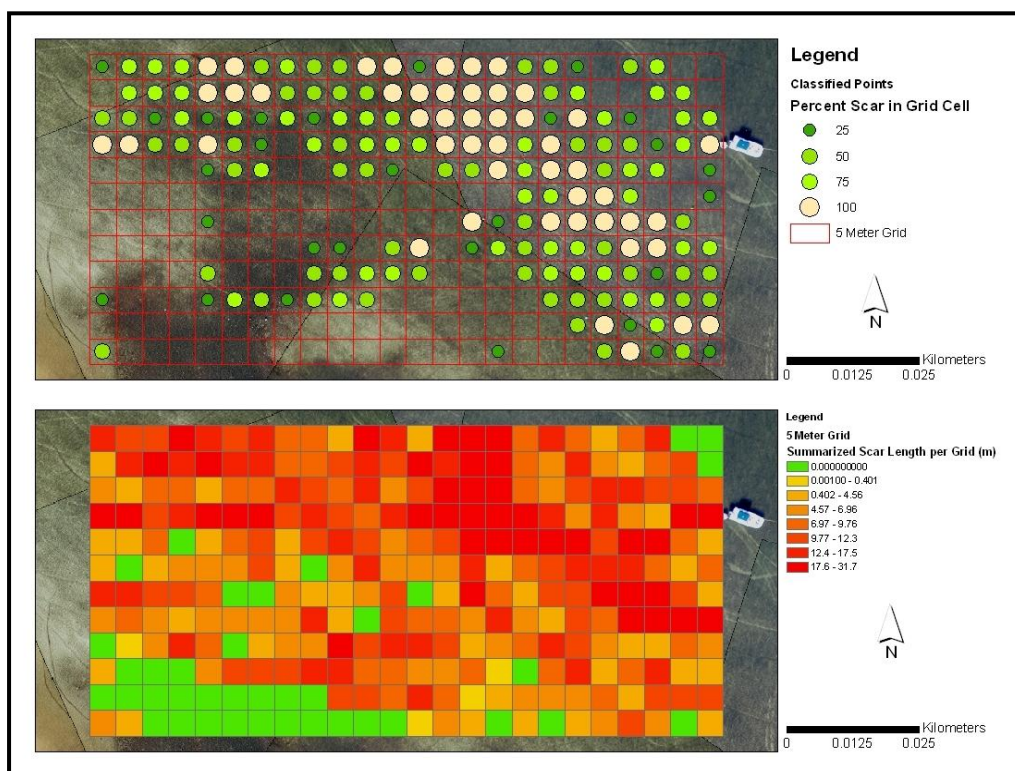
Figure 11. Two techniques used by FWRI to interpret propeller scar aerial photographs located within project sites A (Cove) and B (Point) in St. Andrews Bay Aquatic Preserve.

encompassed an area approximately 70 m x 40 m. Within each monitoring site, five photo plots were selected. Within each plot, four semi-permanent stakes were installed at the corners of a square with sides approximately 20 m long. A Trimble® (model: GeoXH; sub-foot accuracy) handheld device was used to obtain the geographic coordinates of each stake and the distances between stakes. Prior to each set of photos, tall stakes were installed adjacent to the semi permanent stakes, and colored, floating targets were slipped over the tall stakes. The targets serve two purposes for geo-interpreting the photographs. They 1) provide variations in the color-coded identification of individual photo plots, and 2) serve as references for known distances between targets offering an appropriate scale to rectify the imagery. Although the features are visible, they are not always easily identifiable. In this case, geo-interpreting the balloon involved identifying the individual prop scars and digitizing them onto a map. This provides a

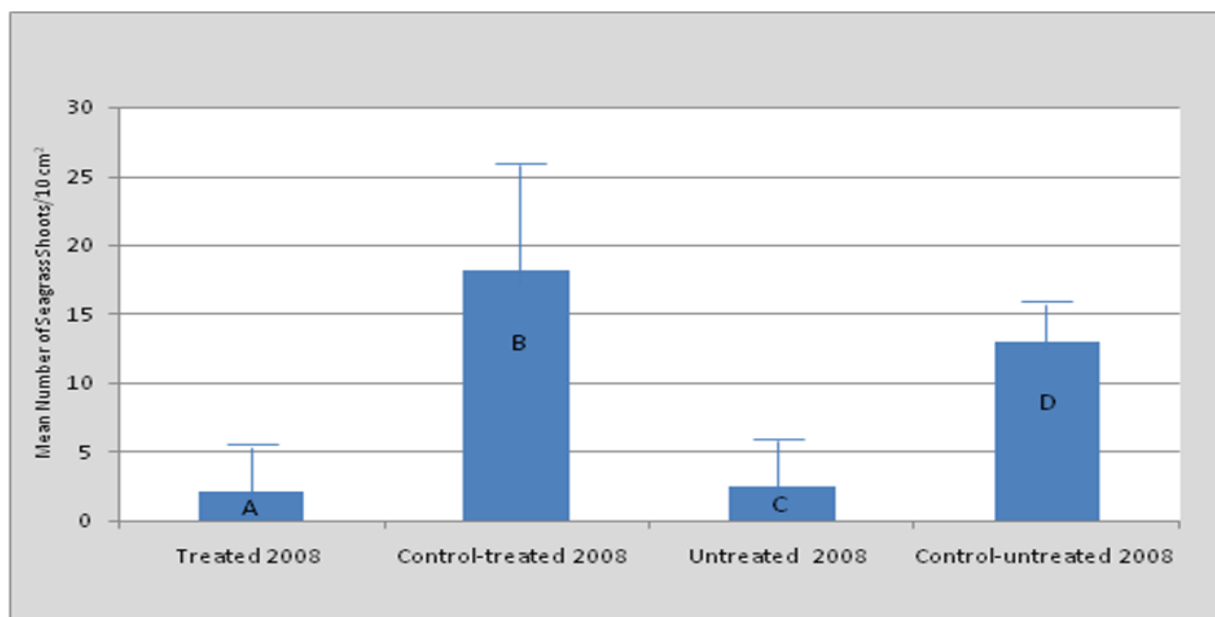
Figure 12. Mean number of seagrass shoot counts in treated and untreated propeller scars in 2008.

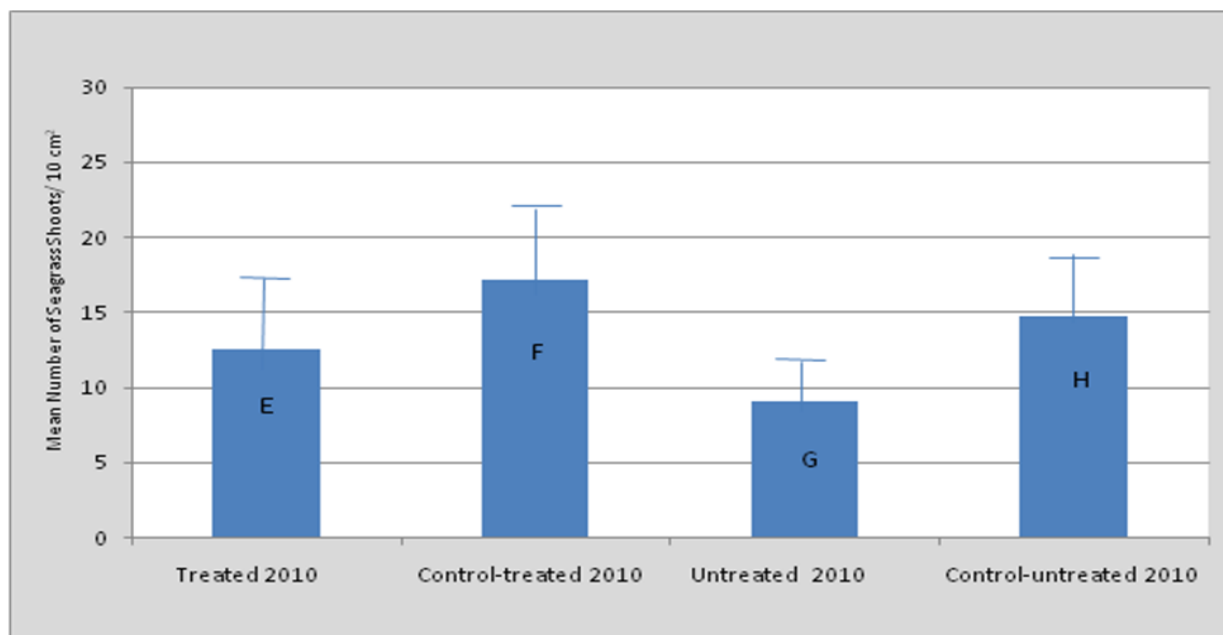
Figure 13. Mean number of seagrass shoot counts in treated and untreated propeller scars in 2010.

scars. Data for this sampling effort are displayed in Figure 13. Means for seagrass short shoot counts between the sediment tube treated (Column E) and untreated (Column G) propeller scars were significantly different from one another ($n - 1 = 11$, $p = 0.010350031$) at this time.

Comparison of the means of shoot counts for the treated (Column E) scars and their respective controls (Column F) continued to be significantly different ($n - 1 = 23, p = 0.002780829$), as did that for the untreated (Column G) scars and their respective controls (Column H) ($n - 1 = 11, p = 0.002188639$).

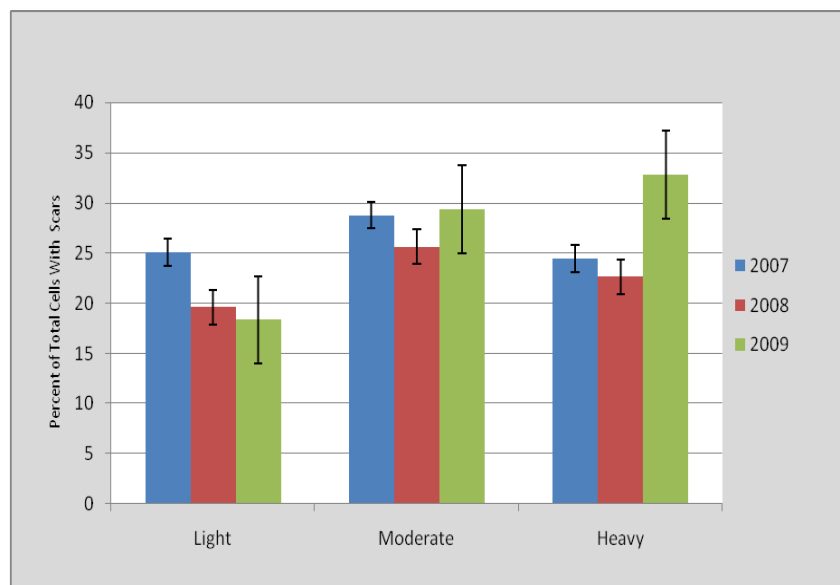
Figure 15. Balloon aerial photography indicating percent of cells containing propeller scars during 2007, 2008 and 2009.

scarring decreased from 2007 to 2009, but moderate and heavy scarring increased over the same period of time (Fig. 15). In addition, the percent of cell that did not have prop scars decreased overall from 2007 to 2009, which also supports the premise that

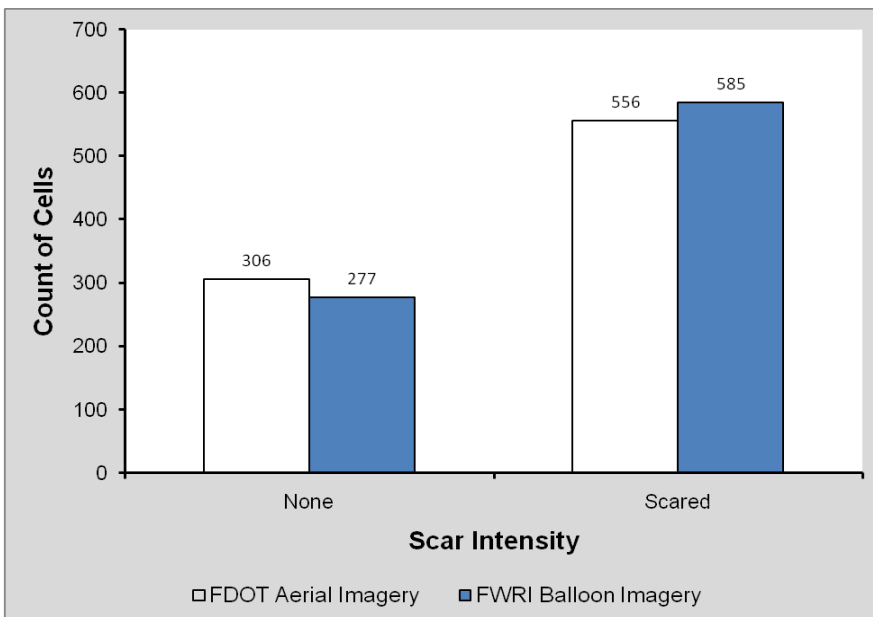
FWC-FWRI also acquired FDOT aerial imagery to determine if these products could be used in a similar fashion to analyze the occurrence of prop scars over time. A comparison of the FWRI balloon imagery and the FDOT aerial imagery was conducted to determine if there was a bias in either photographic methodology. Figure 17 illustrates that both techniques compared favorably in

identifying prop scars within designated grid cells within known locations.

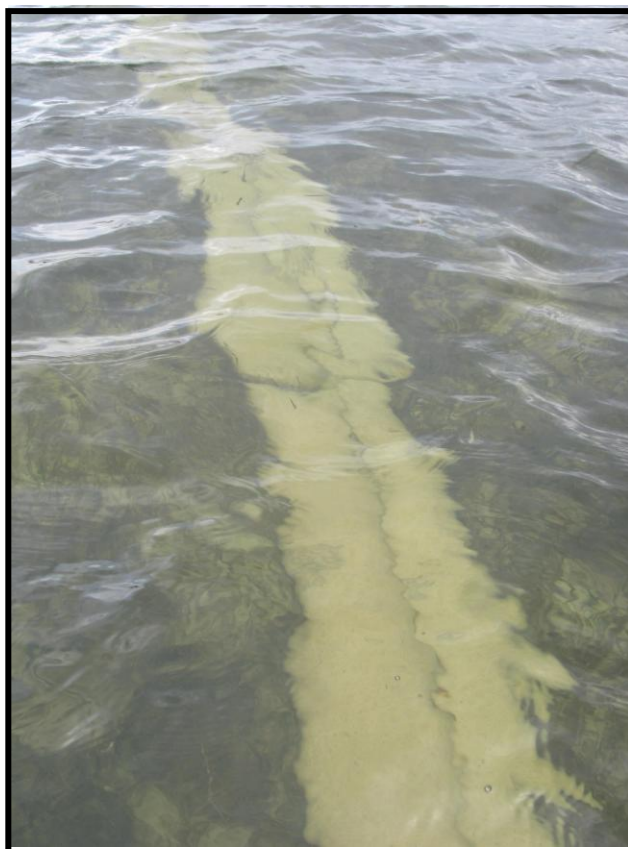
Figure 18. St. Andrews Bay Aquatic Preserve propeller scar with recently placed sediment tubes.

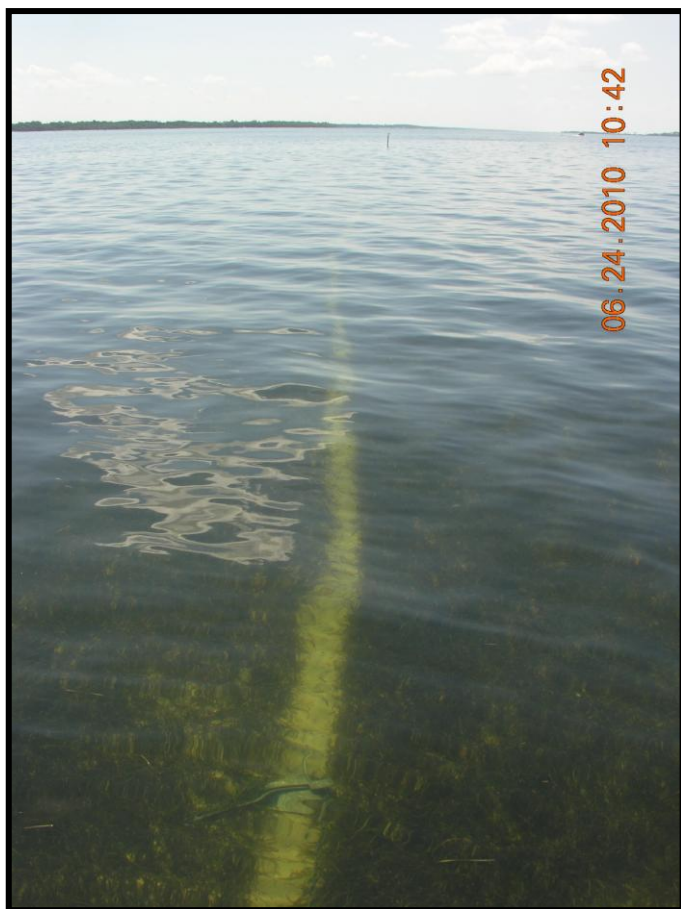
Figure 20. Recent propeller scar located in project site B in St. Andrews Bay Aquatic Preserve.
