Revised Exhibit I

Tavares

(WEST CENTRAL)

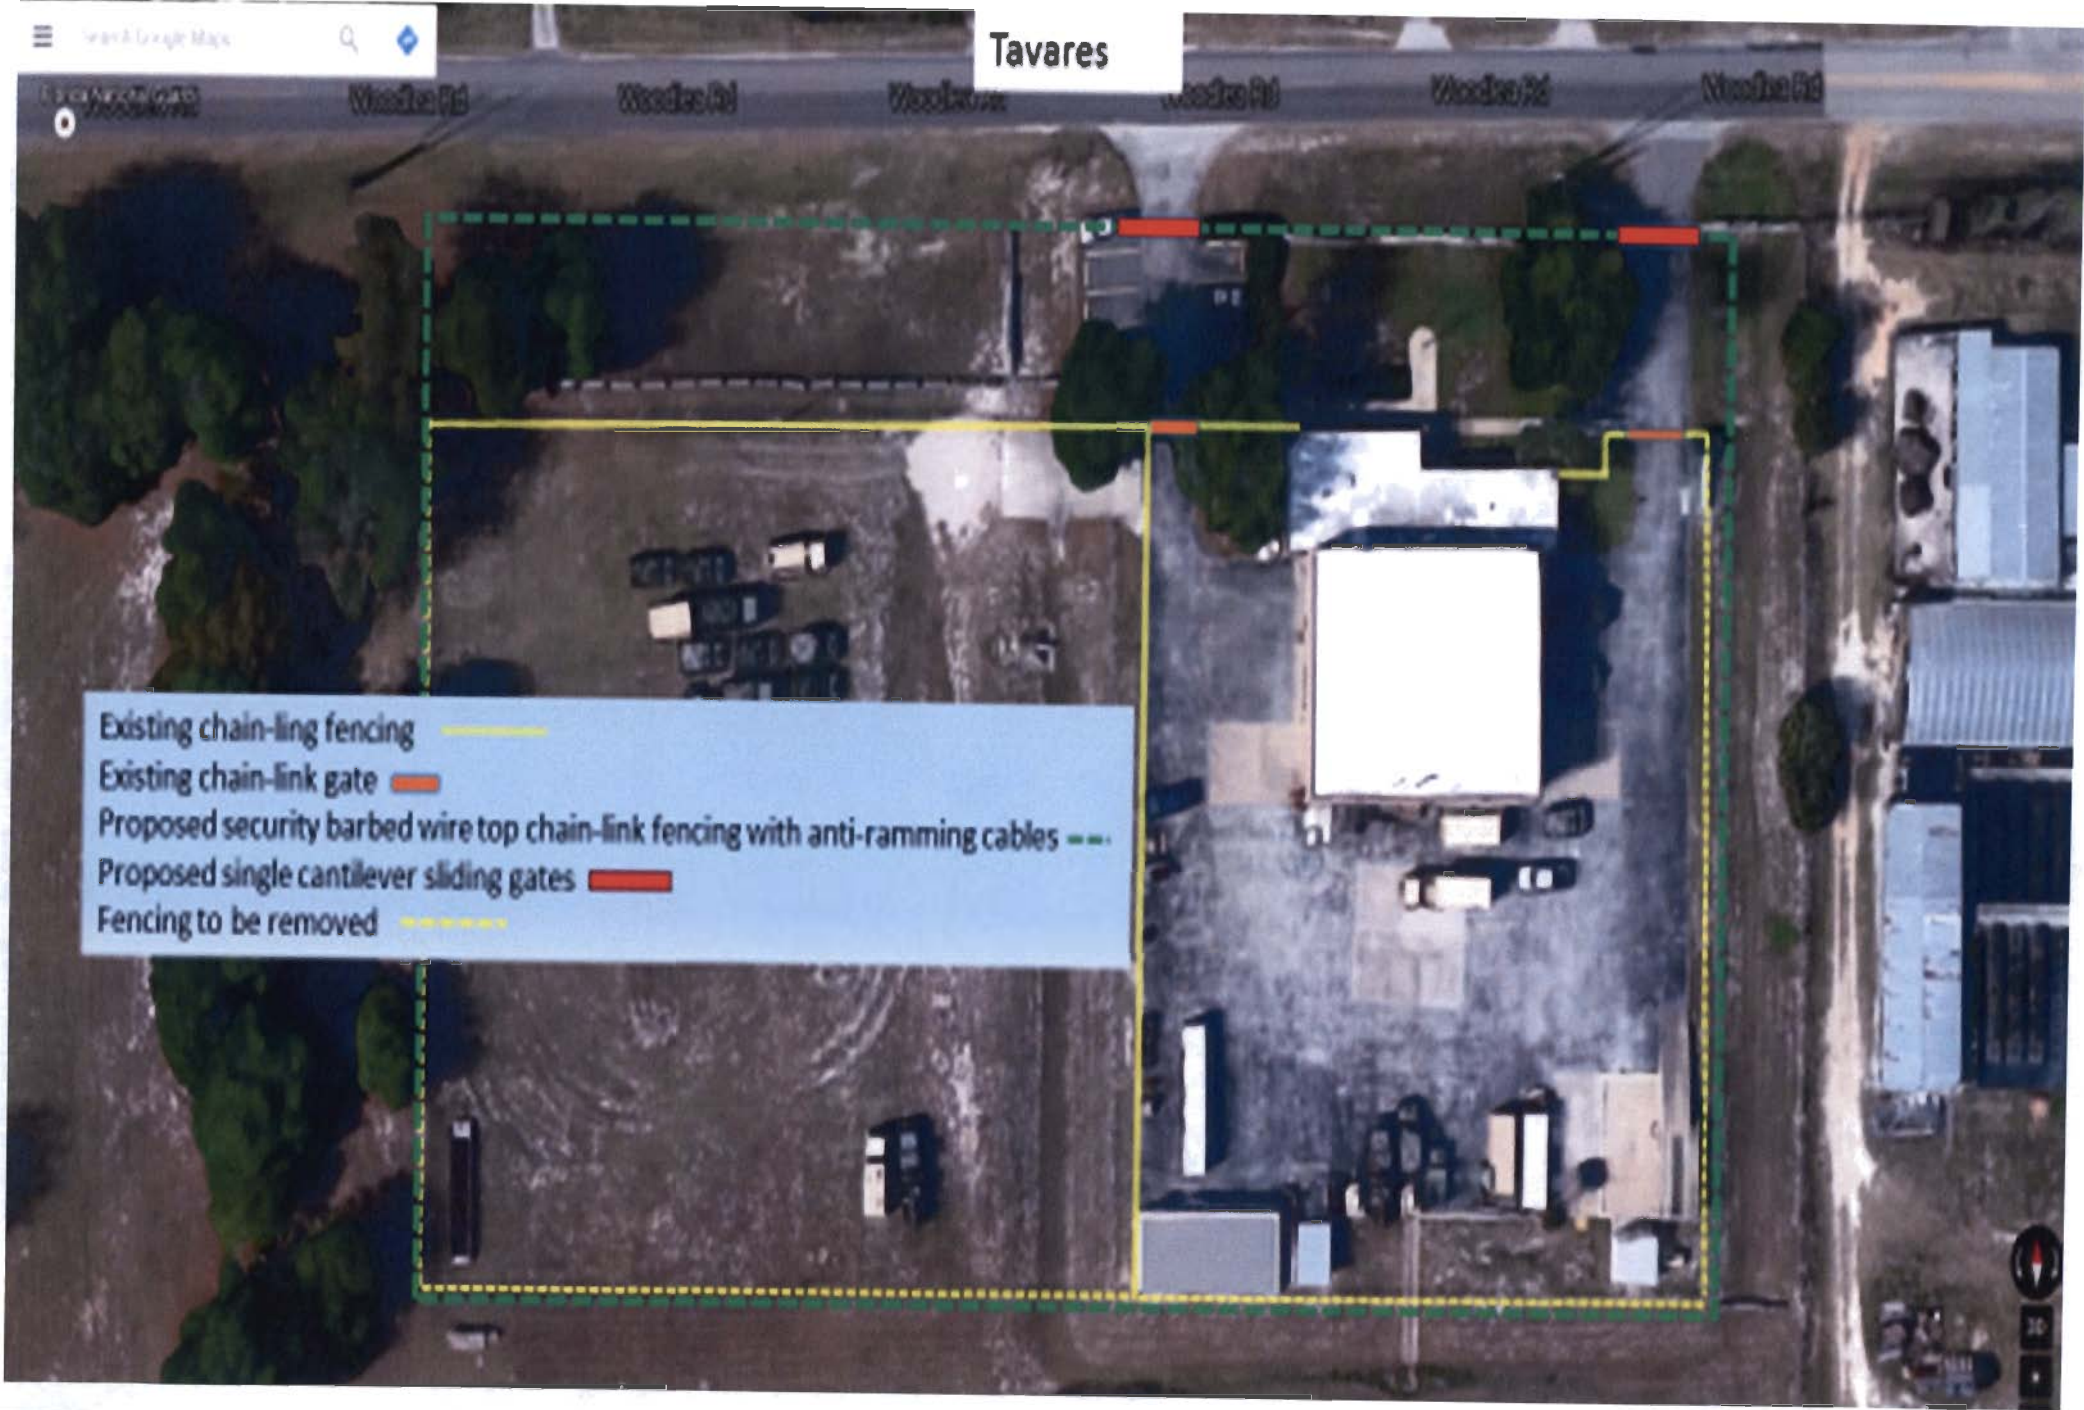
The Tavares Readiness Center currently has barbed wire fencing surrounding the western, eastern and southern perimeters while the northern perimeter is opened and exposed to vehicle and pedestrian traffic.

8 ft. high security barbed wire top chain link perimeter fencing with anti-ramming cables is being requested to help enclose the entire perimeter. This fencing will start on the northwestern boundary, continue east parallel to Woodland Road and stop at the northeastern boundary line. From there the fencing will continue south, run west behind the motor pool, stop at the northwest boundary line and continue back north connecting to the fencing at the northwest boundary. The current barbed wire fencing at the eastern, western and southern locations will be removed.

A single cantilever sliding gate will be placed at two locations north of the Armory parallel to Woodleaf Drive with no more than 2 inch spacing between the bottom of the gate and ground. **NO K12/K8 fencing/gates will be placed at this site.**
